CONFIDENTIAL CLOSE CALL

January 2018

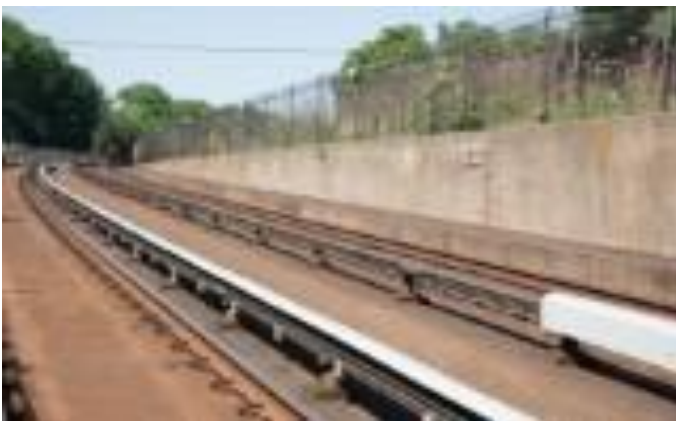
Employee Concern: Missing third rail cover boards

Employees have reported missing third rail cover boards at West Falls Church Yard. Many believe that the third rail cover board is there to protect the employee, but its sole purpose is to protect the third rail from debris and liquids. Replacing cover boards is a constant cycle that WMATA is working to execute more efficiently. In addition Maintenance of Way Engineering (MOWE) is evaluating alternative designs for cover boards.

Actions: Track and Structures (TRST) department has identified and replaced 450 feet of missing cover boards at the reported location.

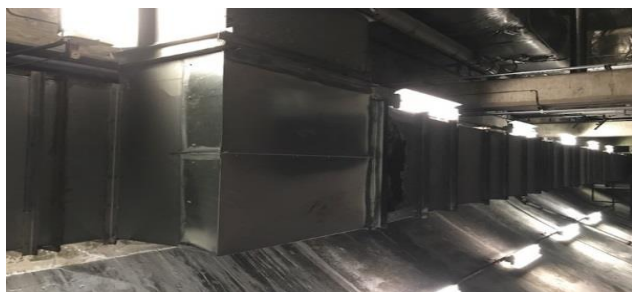
RESOLVED: UPE duct repairs

Employees have observed Fire & Life Safety (FLS) ducts in need of repair in stations and reported these issues to Close Call. According to SOP 209-07 supervisors must schedule failed FLS equipment repairs first. If a Fire & Life Safety duct is not in a failed state at the time reported, immediately taking interim mitigation actions would be an appropriate response from management to address employees' concerns.

Actions: In October, replacement of the UPE ducts began by an outside company. Plant (PLNT) Department management will ensure that assistant superintendents are aware of appropriate interim mitigations until scheduled replacements are made. In the interim, the duct was patched as pictured until permanent renovations begin.

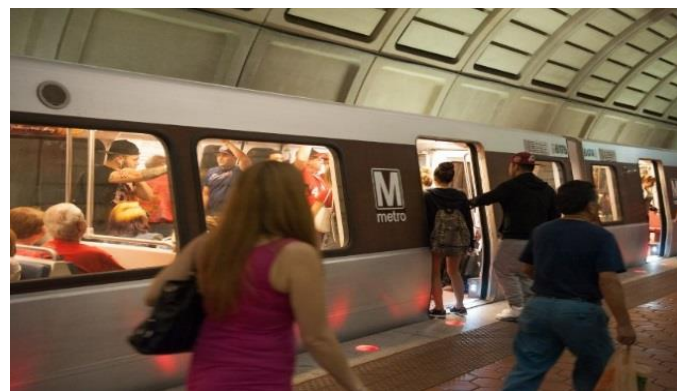
RESOLVED: Misalignment between station platforms and railcar doors

Employees have reported misalignment between station platforms and railcar doors at Braddock Road and Rhode Island Avenue.

Actions: To mitigate hazards until the long term station rehabilitation can be completed, WMATA makes customer announcements at the affected stations. On 7000 series railcars automated announcements are made, with live announcements on all other railcars servicing those stations to warn customers. Also, a PIDS message was created for display. Installation of visual optimal boarding markings on the platforms have been installed at Braddock Road.
